WORLD *COAL*®

ISSUE 4 2022 - VOLUME 31 NUMBER 4

GET A HANDLE ON CONVEYOR HAZARDS

Bernd Küsel,
CBG Conveyor Belt Gateway,
Germany, evaluates hazards for steel
cord conveyor belts.

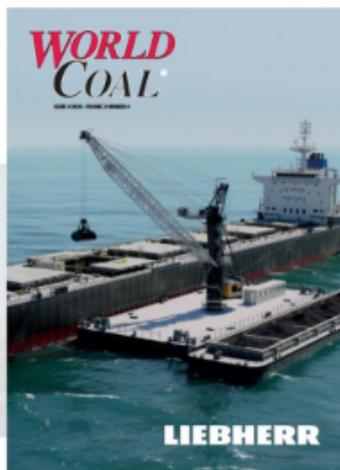
ON THE COVER

Designed for a new era of bulk handling: the all-electric transshipment crane CBG 500 E combines the market demands for a reliable crane with high handling capacities. Due to the electric drives, the available energy is used efficiently and the crane operates in an environmentally friendly manner. The CBG 500 E has a boom length of up to 50 m and handles up to 2000 tph. In sheltered water the maximum load capacity in grab operation is 90 t and in open water 65 t.

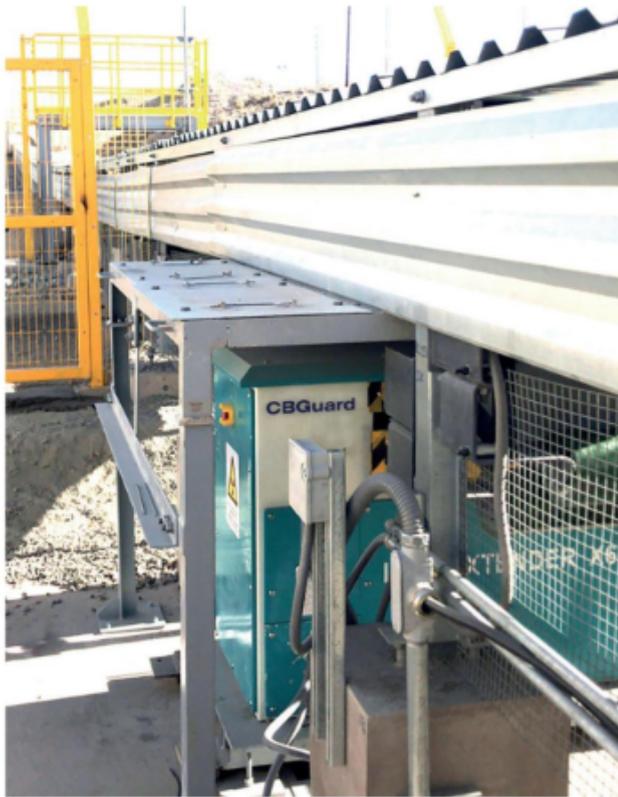
Figure 1. A CBGuard Life Extender in an overland conveyor.

To help try and improve belt safety and service life, Conveyor Belt Gateway jointly designed the CBGuard Life Extender monitoring system. This enables repairs to the conveyor belt to be carried out at the best possible time. The clear X-ray images that capture every cubic millimetre of the conveyor belt allow maintenance personnel to decide whether repairs should be made in the short term, or whether it is still

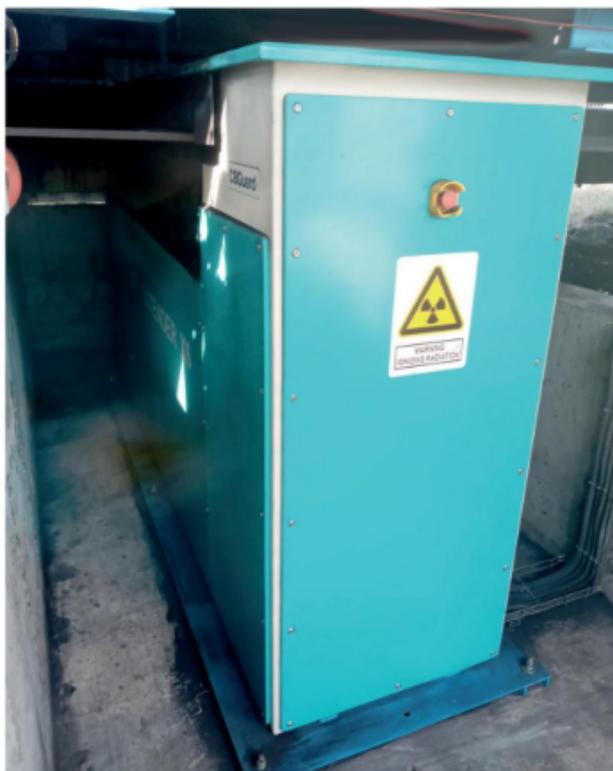
Figure 2. A CBGuard in a coal handling conveyor.

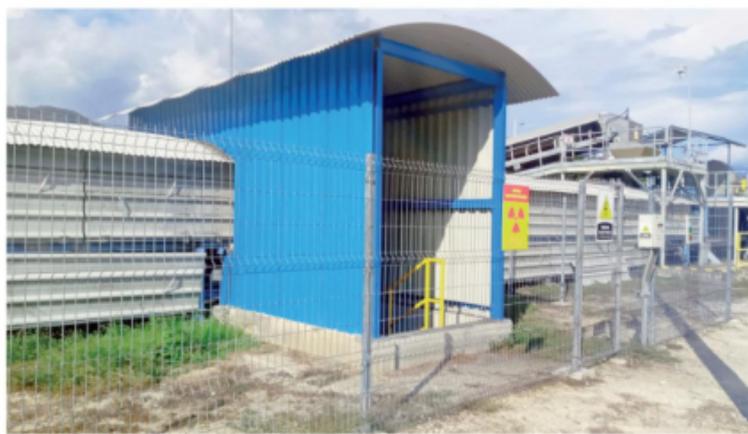
Figure 3. Service entrance for a CBGuard Life Extender.

The compact design and low weight of the scanner allows easy and quick installation, and it is largely wear-free because it has no moving parts or contact with the conveyor belt.
